DRY CREEK FLOOD REVIEW

JULY 9, 1996

Pueblo, Colorado

Dry Creek Flood Review

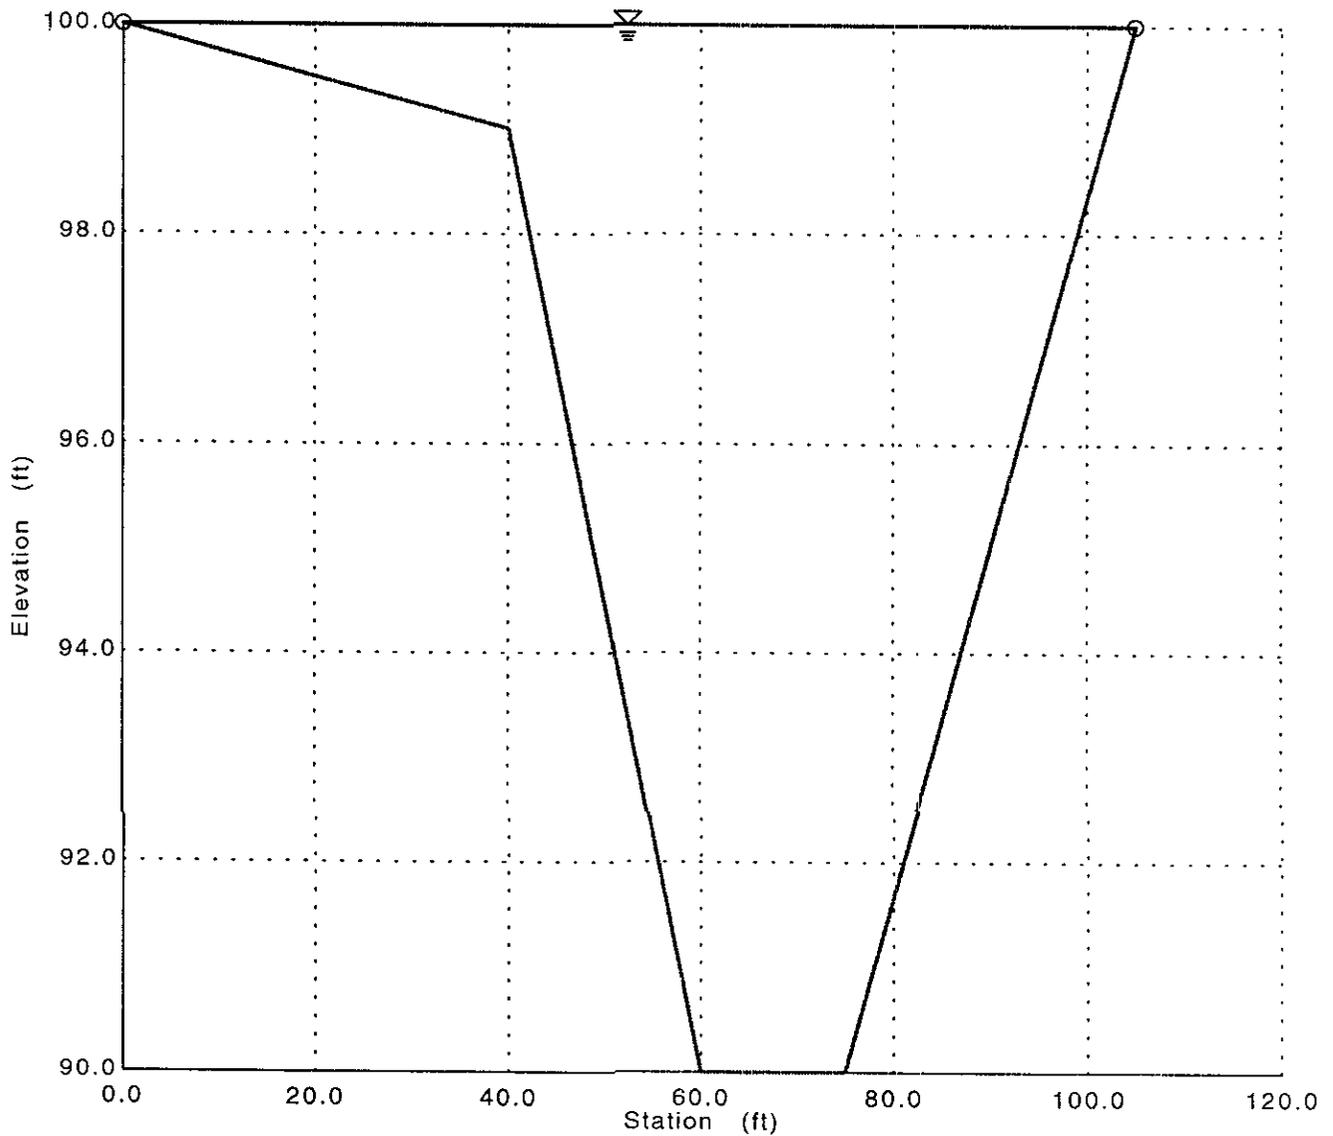
surveyed two channel and floodplain cross sections. From the field data, CWCB staff computed a flood discharge from the July 9, 1996 flood event using the slop-area method. The estimated discharges are 3,100 cfs and 3,600 cfs respectively (See Attachment C-1 and C-2).

Dry Creek at Pueblo, downstream section
Cross Section for Irregular Channel

Section Data	
Wtd. Mannings Coefficient	0.040
Channel Slope	0.006000 ft/ft
Water Surface Elevation	100.00 ft
Discharge	3,097.37 cfs

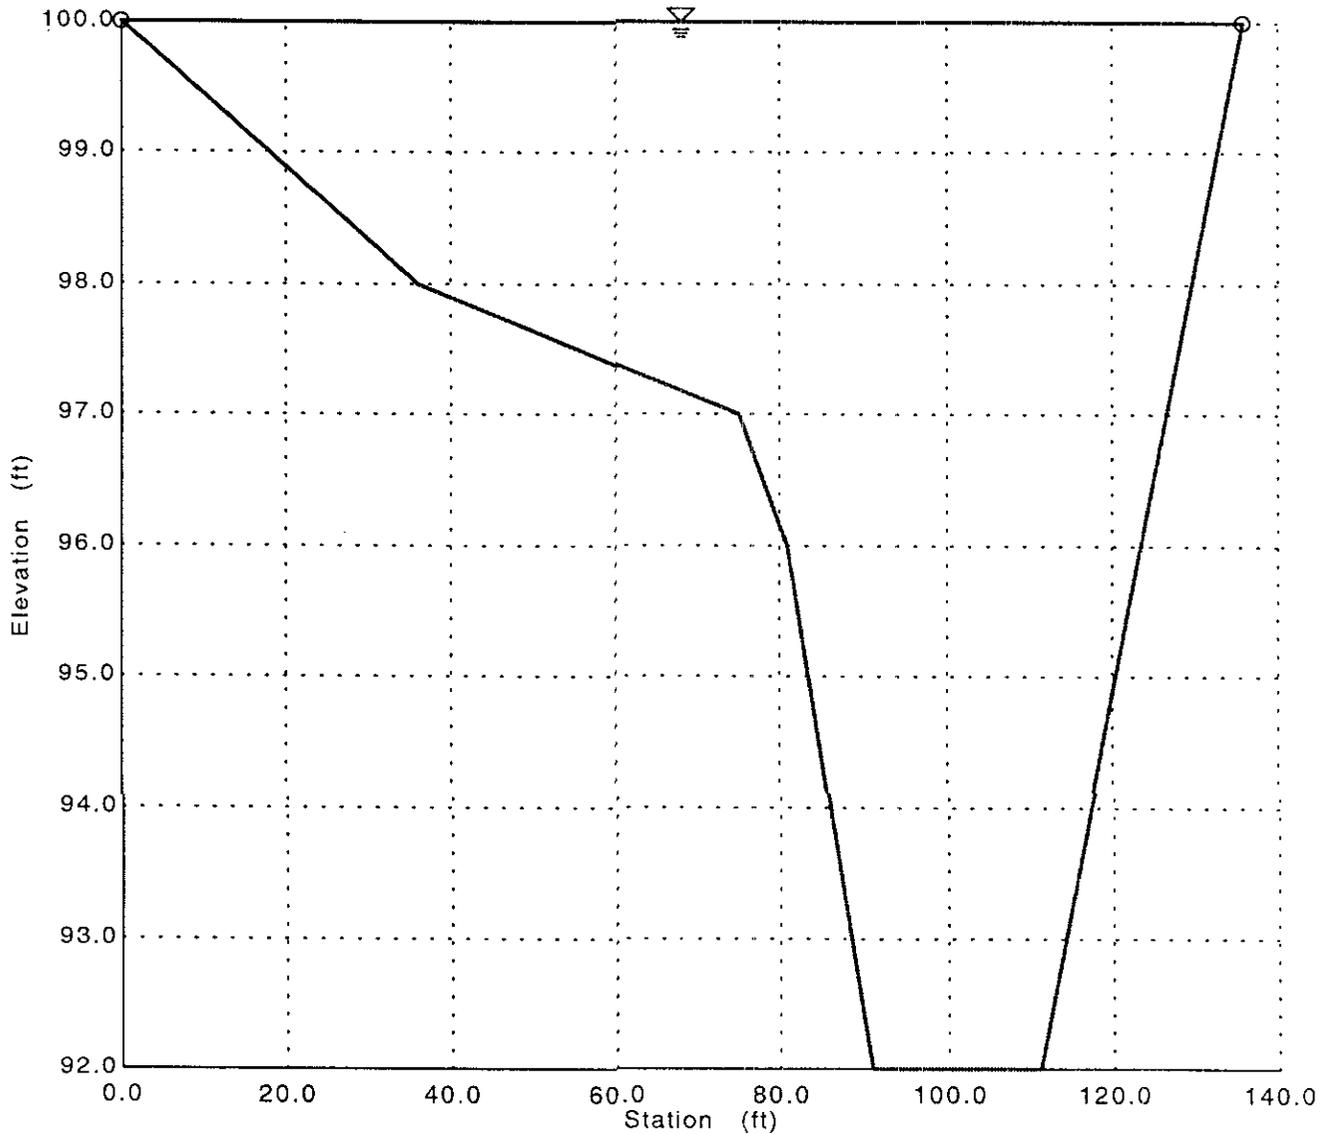
Attachment C-2

Dry Creek at Pueblo, upstream section
Cross Section for Irregular Channel

Section Data		
Wtd. Mannings Coefficient	0.040	
Channel Slope	0.008000 ft/ft	
Water Surface Elevation	100.00	ft
Discharge	3,588.65	cfs

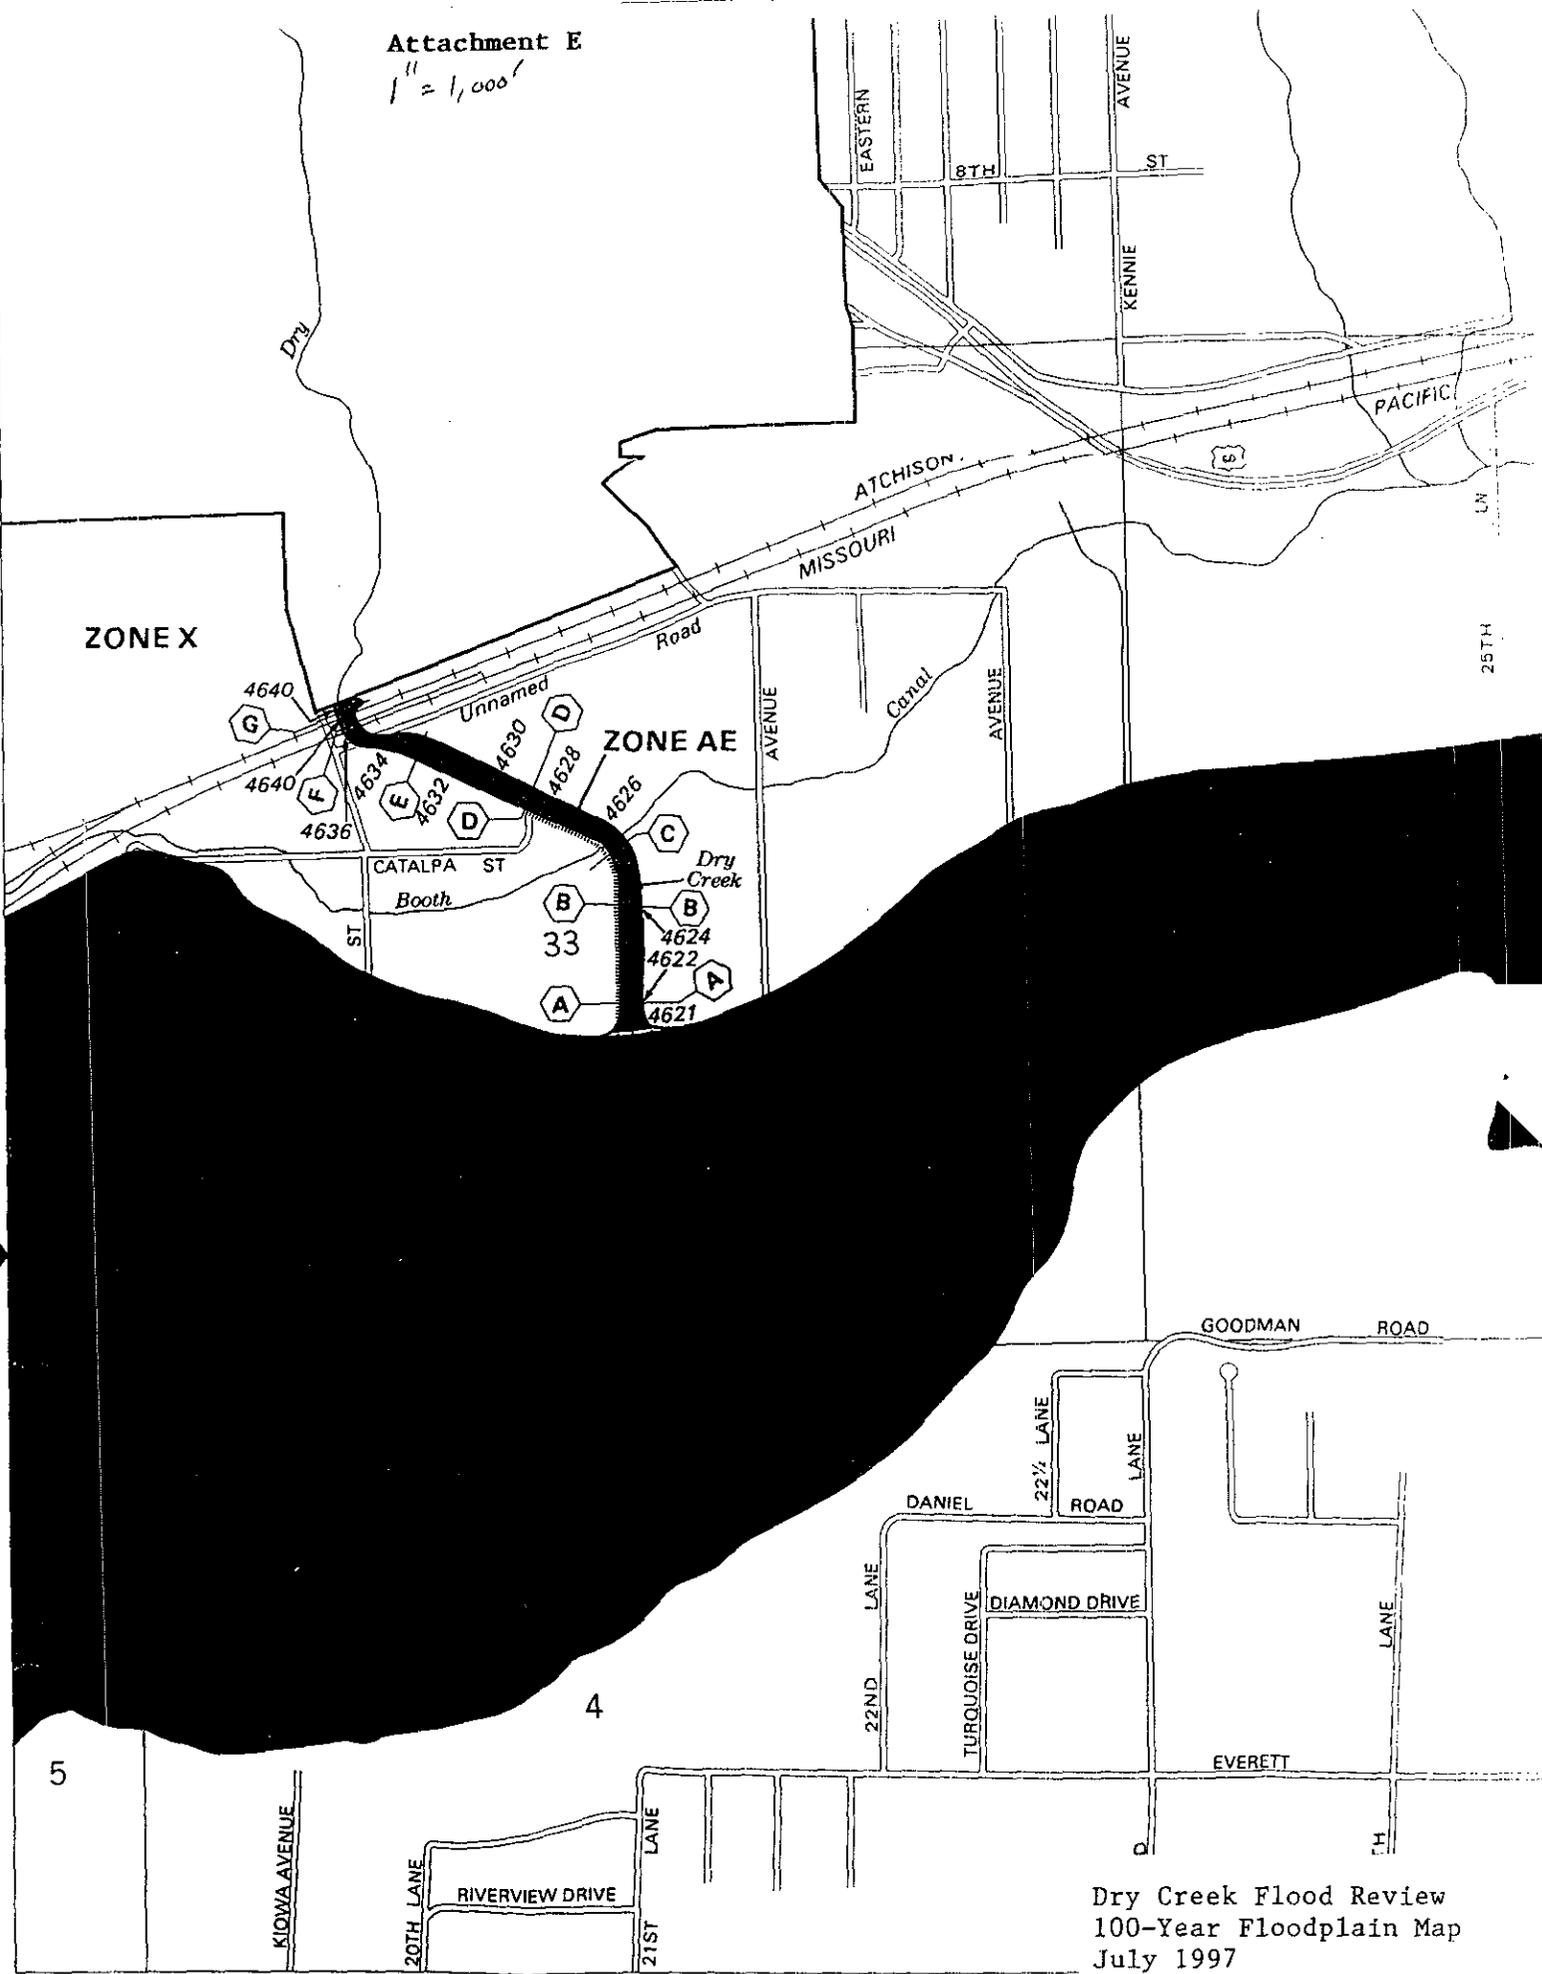
Attachment E

The Board staff finds that the July 9, 1996 flood event was greater than the 100-year flood event. The roadway crossing of the stream immediately downstream of the Missouri-Pacific Railroad is a concrete "ford," otherwise known as a "Texas Crossing." It appears that the stream crossing does not have enough capacity to contain the 100-year flood flow. During the July 9, 1996 flood, high water overtopped the right overbank and flooded Booth Street, causing a flood condition in areas not identified on the FEMA floodplain map (Attachment E).
