REPORT No. CDOH-P&R-R&SS-76-5

" EROSION CONTROL  
AND REVEGETATION  
ON VAIL PASS: Final Report "

HERB SWANSON  
COLORADO DIVISION OF HIGHWAYS  
PLANNING AND RESEARCH DIVISION  
4201 E. ARKANSAS AVENUE  
DENVER, COLORADO 80222

NOVEMBER 1976  
FINAL REPORT

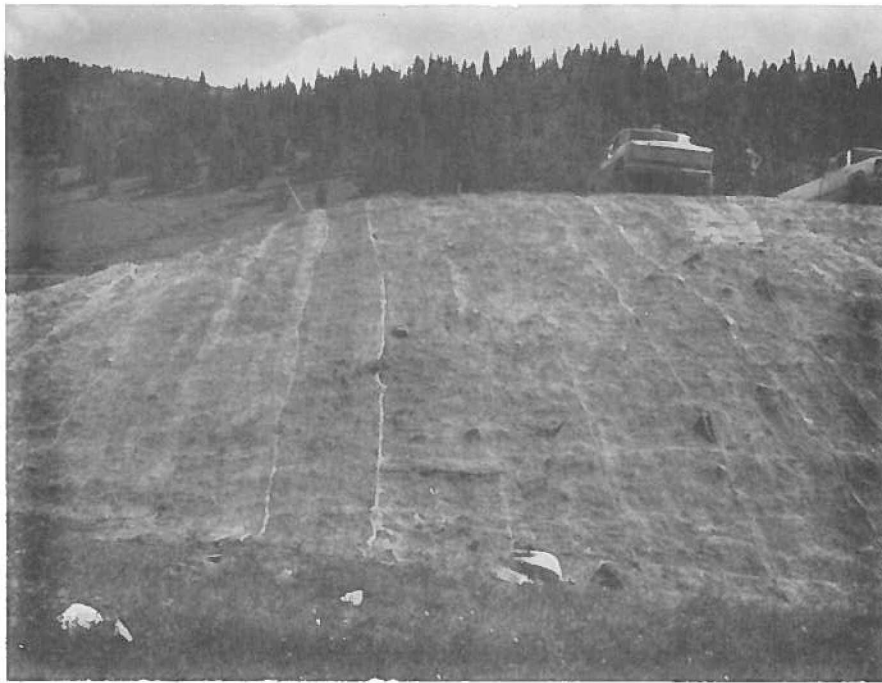
Control Section

Seed & Fert.  
Straw & Jute  
First Year

July 1975

This section is composed of seed, fertilizer, straw mulch and jute mat. This section is identical to the project specifications and is used as a comparison for all other test sections. The cost of this type of erosion control is \$4,480 per acre. (See Table 1.)

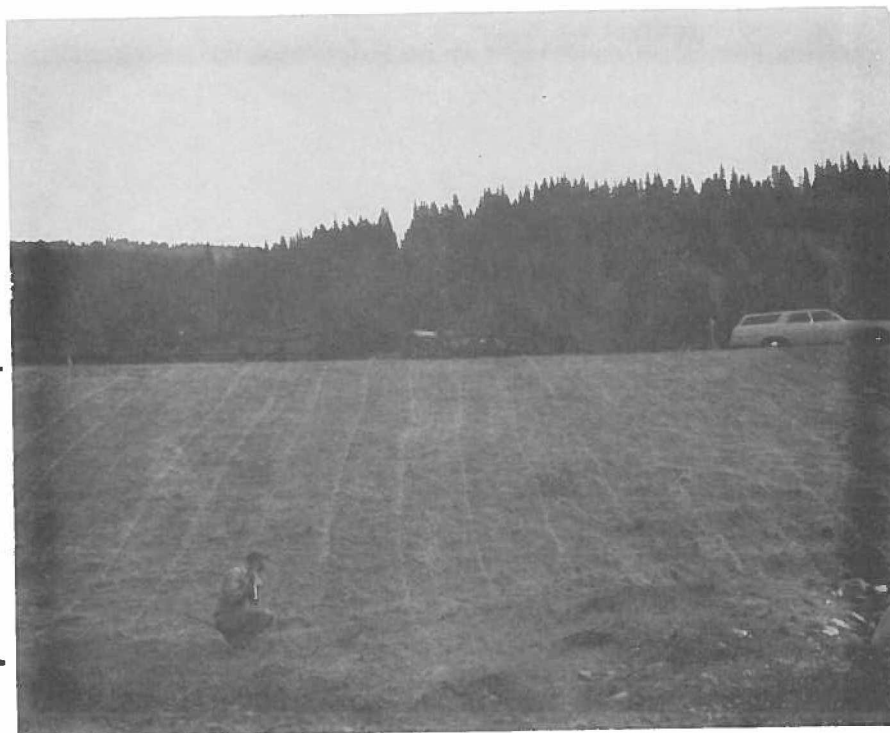
Sec. 2

Seed & Fert.  
Hyd. Mulch II  
1400 lb/Acre  
& Jute  
First Year

July 1975

Hydromulch was used in place of straw in this section. This design produced vegetation nearly as good as the control. There is no particular advantage in the use of this design since the cost is slightly higher. Cost = \$4,490/acre.

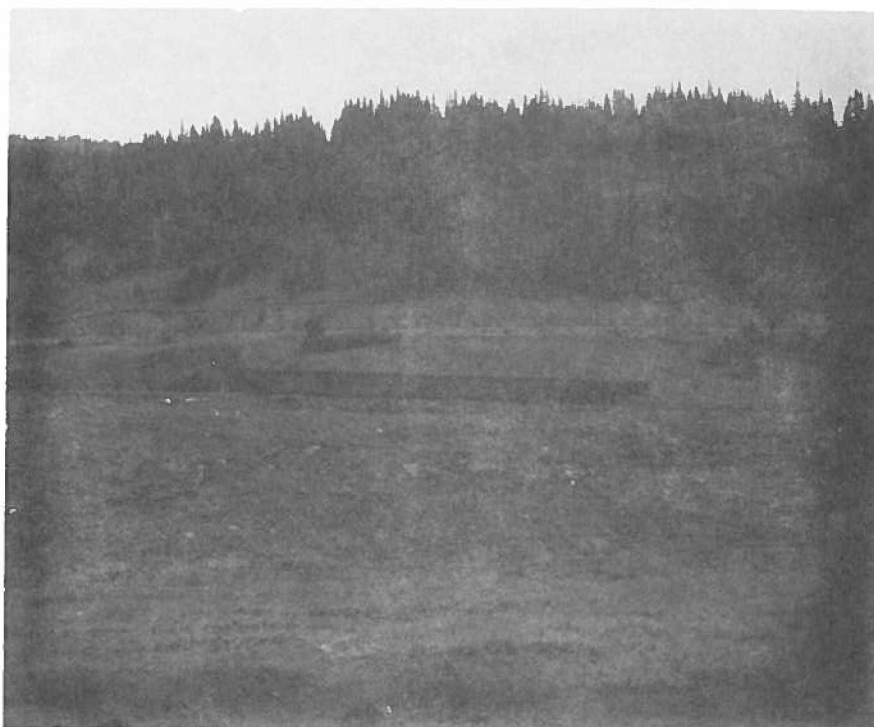
Sec. 4

Seed & Fert.  
Hyd. Mulch II  
First Year

July 1975

These three sections are a comparison of different rates of application of Hydromulch. Section 5 has produced slightly better vegetation than the other two, but differences are so slight that economics must be the deciding factor. Section 5 had the lightest application (1000 lbs/acre). None of these three application rates of Hydromulch produced vegetation quite as dense or vigorous as the standard control section. Costs = \$550/acre, 490/acre and 430/acre respectively.

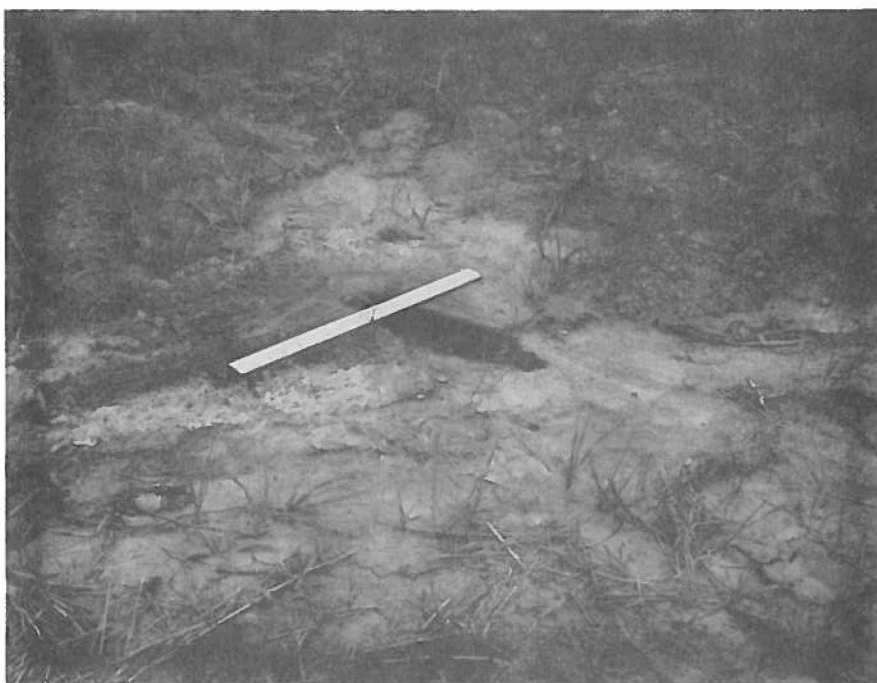
There has been very little erosion of any of the test area. Photograph number 5 shows some minor erosion and photograph number 6 shows the minor sedimentation at the bottom of the slope. Erosion has been insignificant partly because this is not a very steep slope (6:1). Therefore, this study has primarily tested vegetative growth through various materials.

Sec. 4                      July 1975  
 Silt deposition at the bottom of the slope

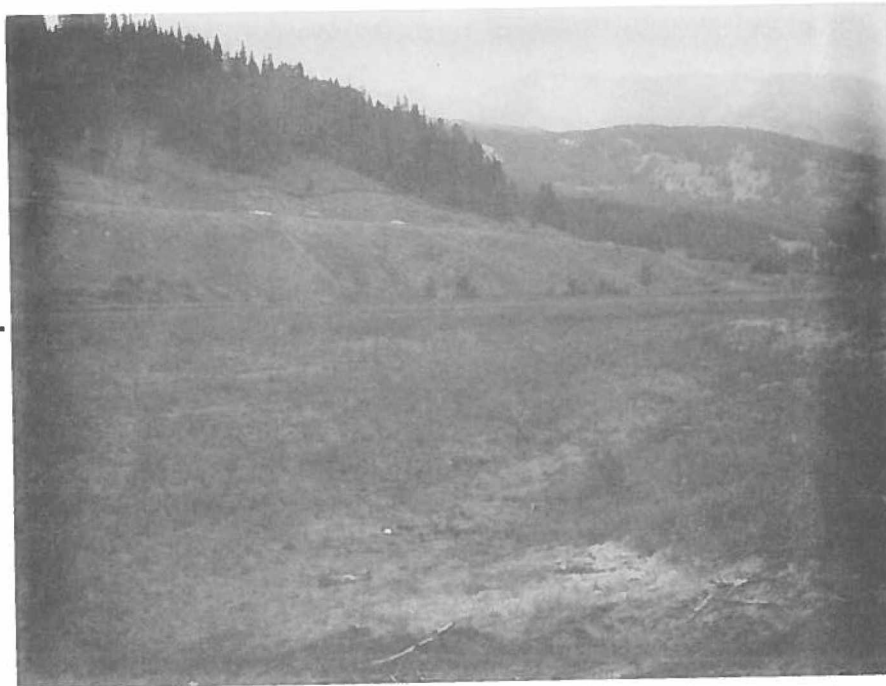
Sec. 13

Seed & Fert.  
Crimped Straw  
First Year's Growth

July 1975

Note: More vegetation in these two than in  
any others at this time.

The use of crimped straw only provided early and better cover than all other sections including the control which is the project standard specifications. This treatment is also one of the most economical. Cost = \$480/acre.

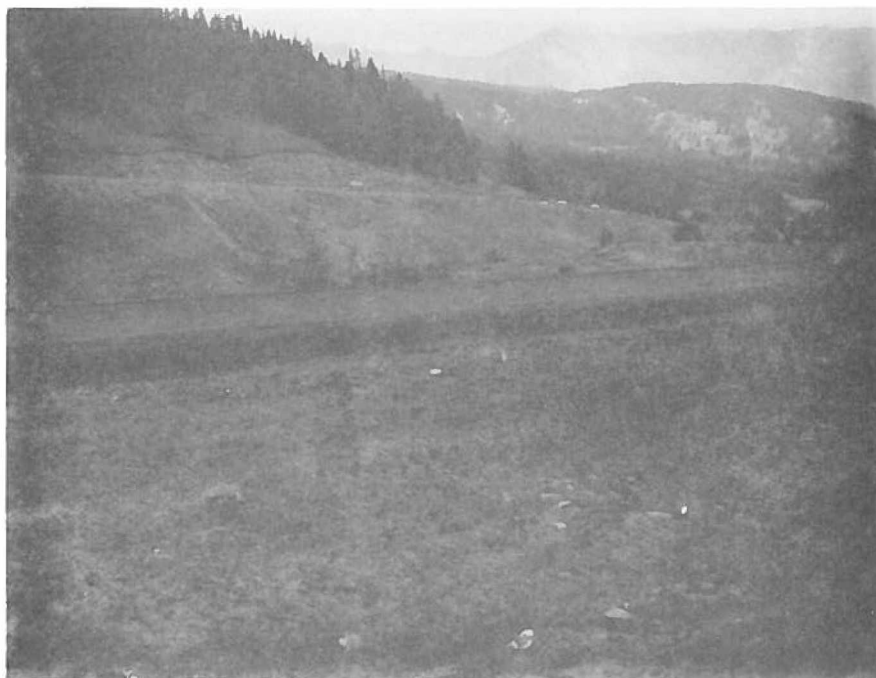
Sec. 14

Seed & Fert.  
only  
First Year

July 1975

No erosion control measure was taken in this section. Vegetation in this section got an earlier start and was considerably better than the control section during 1975. It has been just about the same as the control in 1976. Cost = \$280/acre.

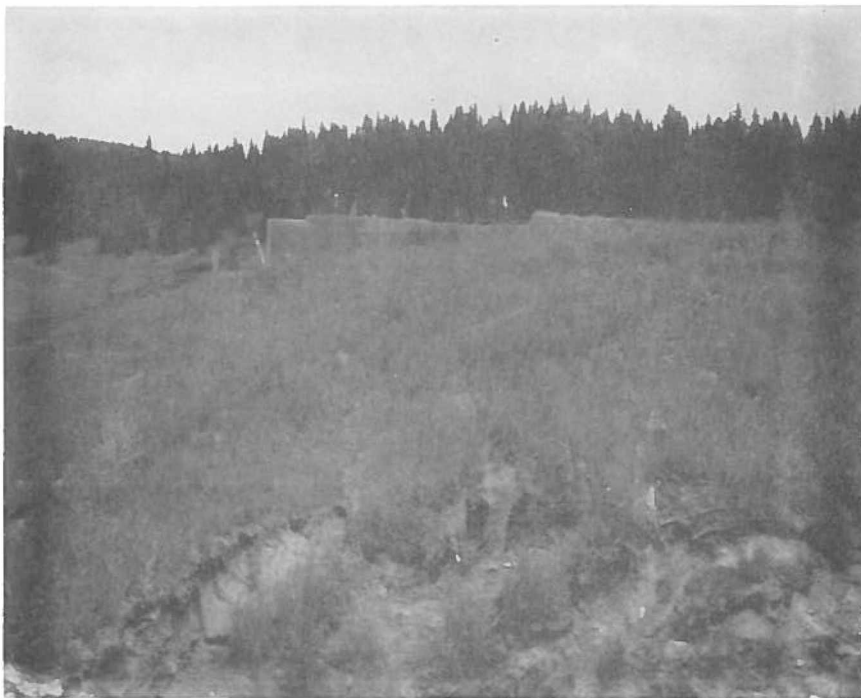
Control Section

Seed & Fert.  
Straw & Jute  
Second Year's  
Growth

August 1976

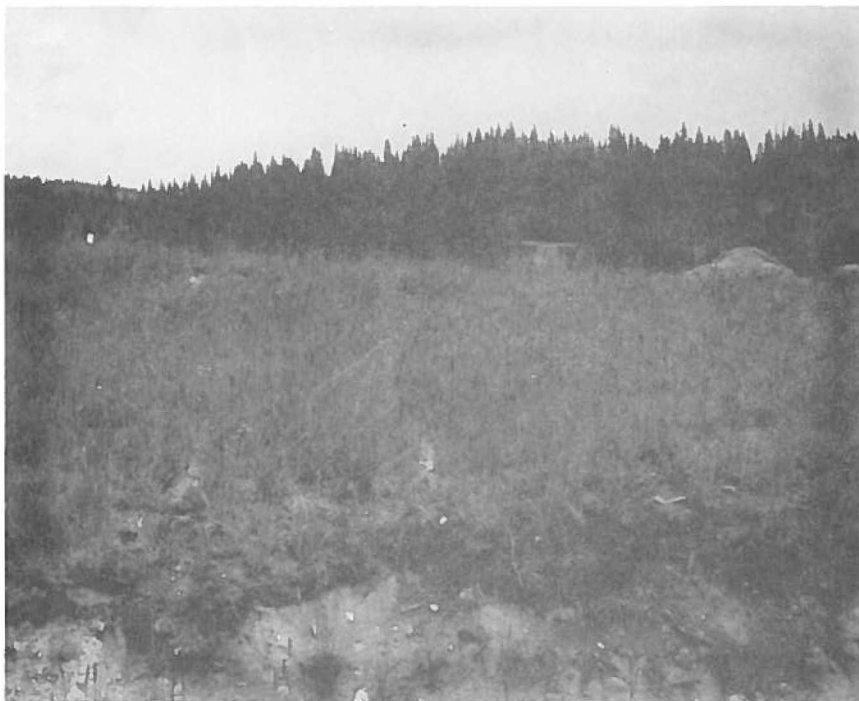
Sec. 1

Seed & Fert.  
Jute  
Second Year

August 1976

The bottom of this slope was cut by the  
contractor for access to a structure.

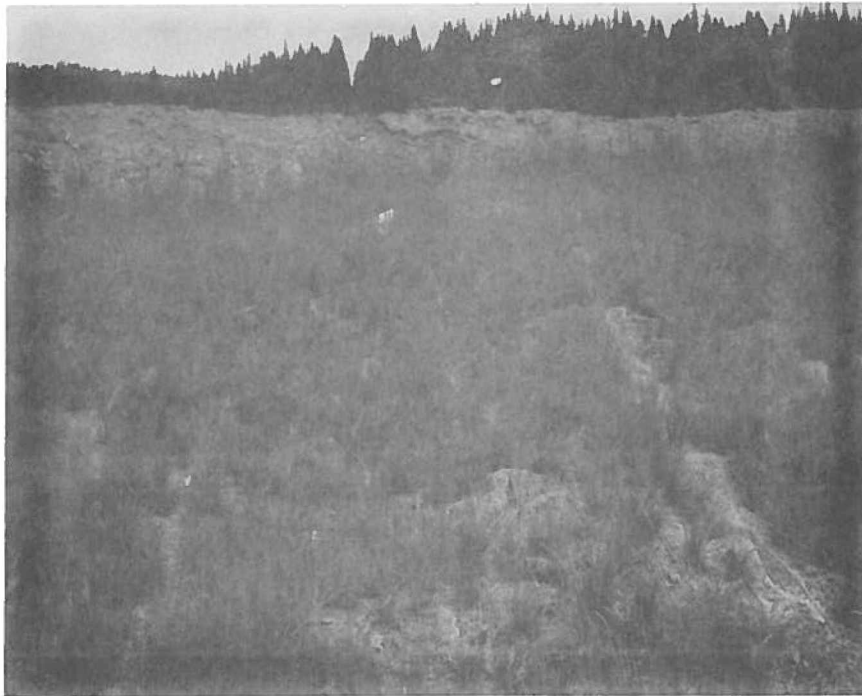
Seed & Fert.  
Hyd. Mulch II  
& Jute  
Second Year

Sec. 2 August 1976  
Lack of vegetation where a space was  
left between the soil and the Jute

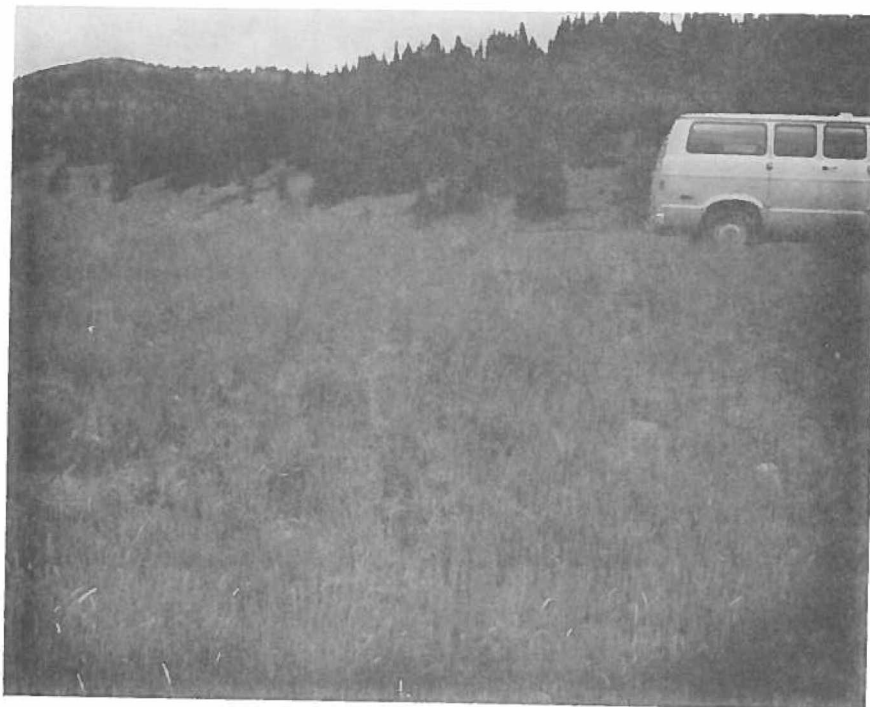
Sec. 4 August 1976

Seed & Fert.  
Hyd. Mulch II  
Second Year

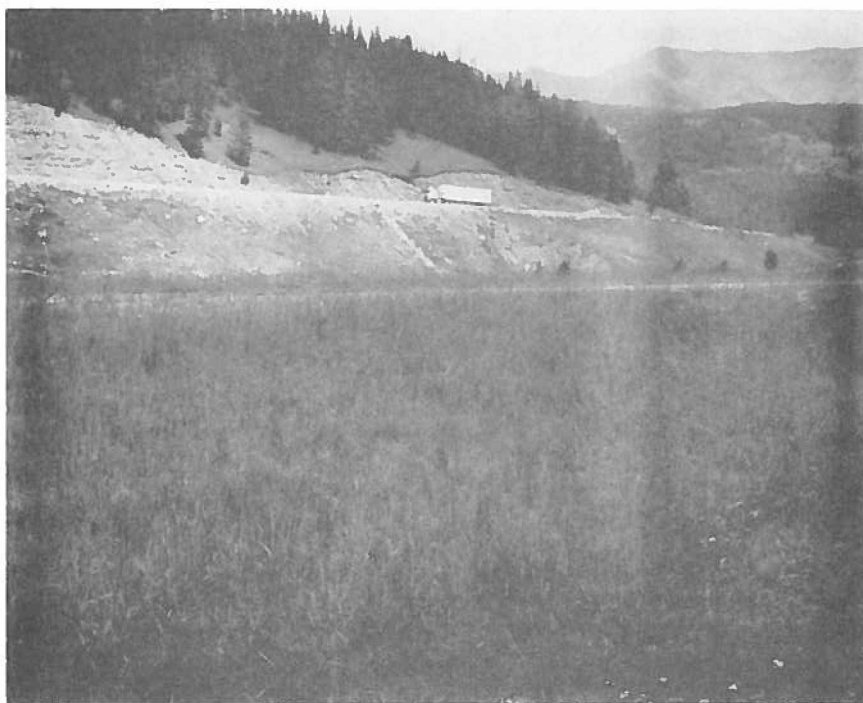
Seed & Fert.  
Straw  
Second Year

Sec. 13 August 1976

Note: Section 13 has continued to produce the most dense and vigorous vegetation.

Seed fertilizer and crimped straw, as was used in Section 13, should be placed on several limited areas on steeper slopes to further test the conclusions of this study. Petroset should also be tested on some steeper slopes since it produces vegetation as good as the standard, jute mat. Project engineers on high altitude projects are encouraged to use crimped straw only or Petroset, especially if provisions can be made to reseed small areas which may be eroded during the first high run off season. Engineering judgment is to be exercised in the selection of these sites as even jute mat does not provide immunity to erosion under severe conditions.
